Government of Northwest Territories
Assessment of Climate Change Impacts on Infrastructure in all NWT communities using the PIEVC protocol
 Northwest Territories, Canada

Map 28
Aklavik Risk Profile

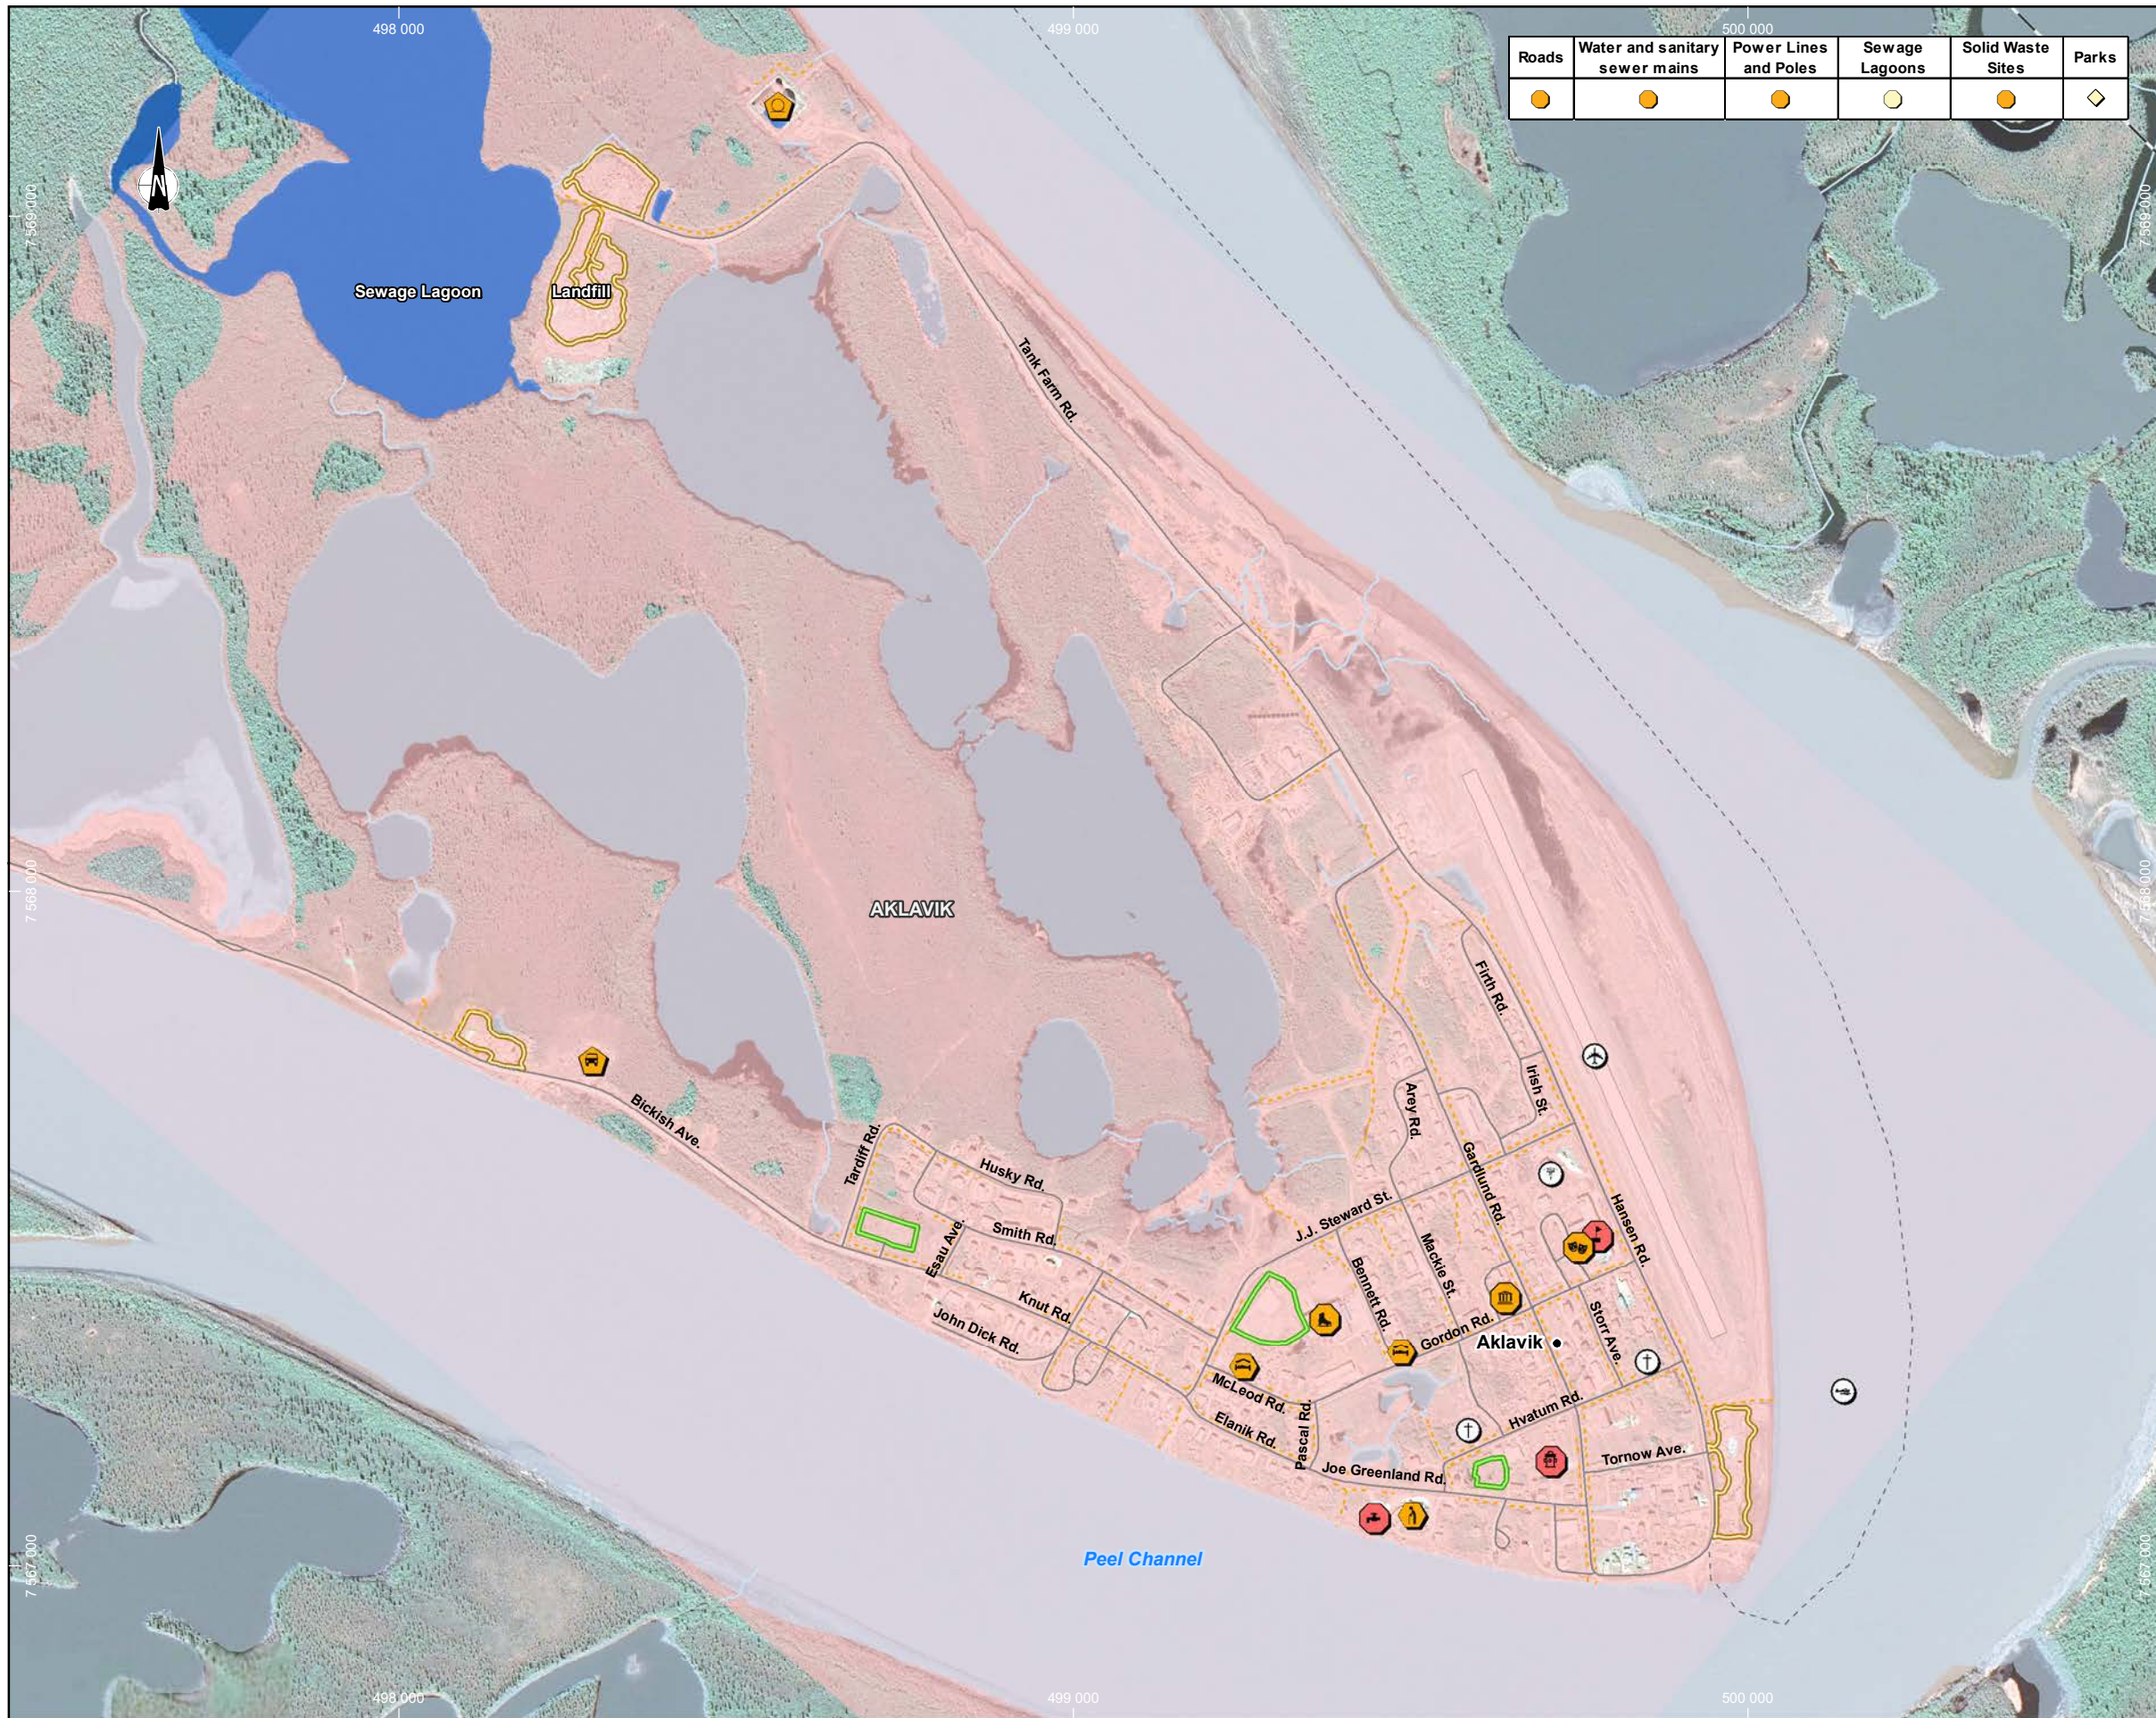
Roads	Water and sanitary sewer mains	Power Lines and Poles	Sewage Lagoons	Solid Waste Sites	Parks

Municipal Boundary		Community
	Park / Recreation Area		Cultural Centre
	Arena		Religious Building
	Lodging Facility		Medical Centre
	Pits, Borrow Sites, Quarries, Dump Sites		Municipal Hall
	Educational Building		Senior Citizens Home
	Fire Station		Tank
	Garage		Water Treatment Plant
Transport			Airport
	Other street or road		Seaplane Base
	Trail		Permanent Watercourse
Hydrography			Ditch
	Waterbody		Floodway Fringe
	Lagoon / Reservoir / Dugout		Precipitation Increase
Historical Floodplain			Wildfire
	Floodway		Wind Increase
Risk Type			Moderate-low
	No Identified Risk		Moderate-high
	Flooding and Coastal Erosion		High
	Permafrost Degradation		
Risk Level			
	No Identified Risk		
	Low
