Government of Northwest Territories  
**Assessment of Climate Change Impacts on Infrastructure in all NWT communities using the PIEVC protocol**  
 Northwest Territories, Canada

**Map 10  
 Gameti Risk Profile**

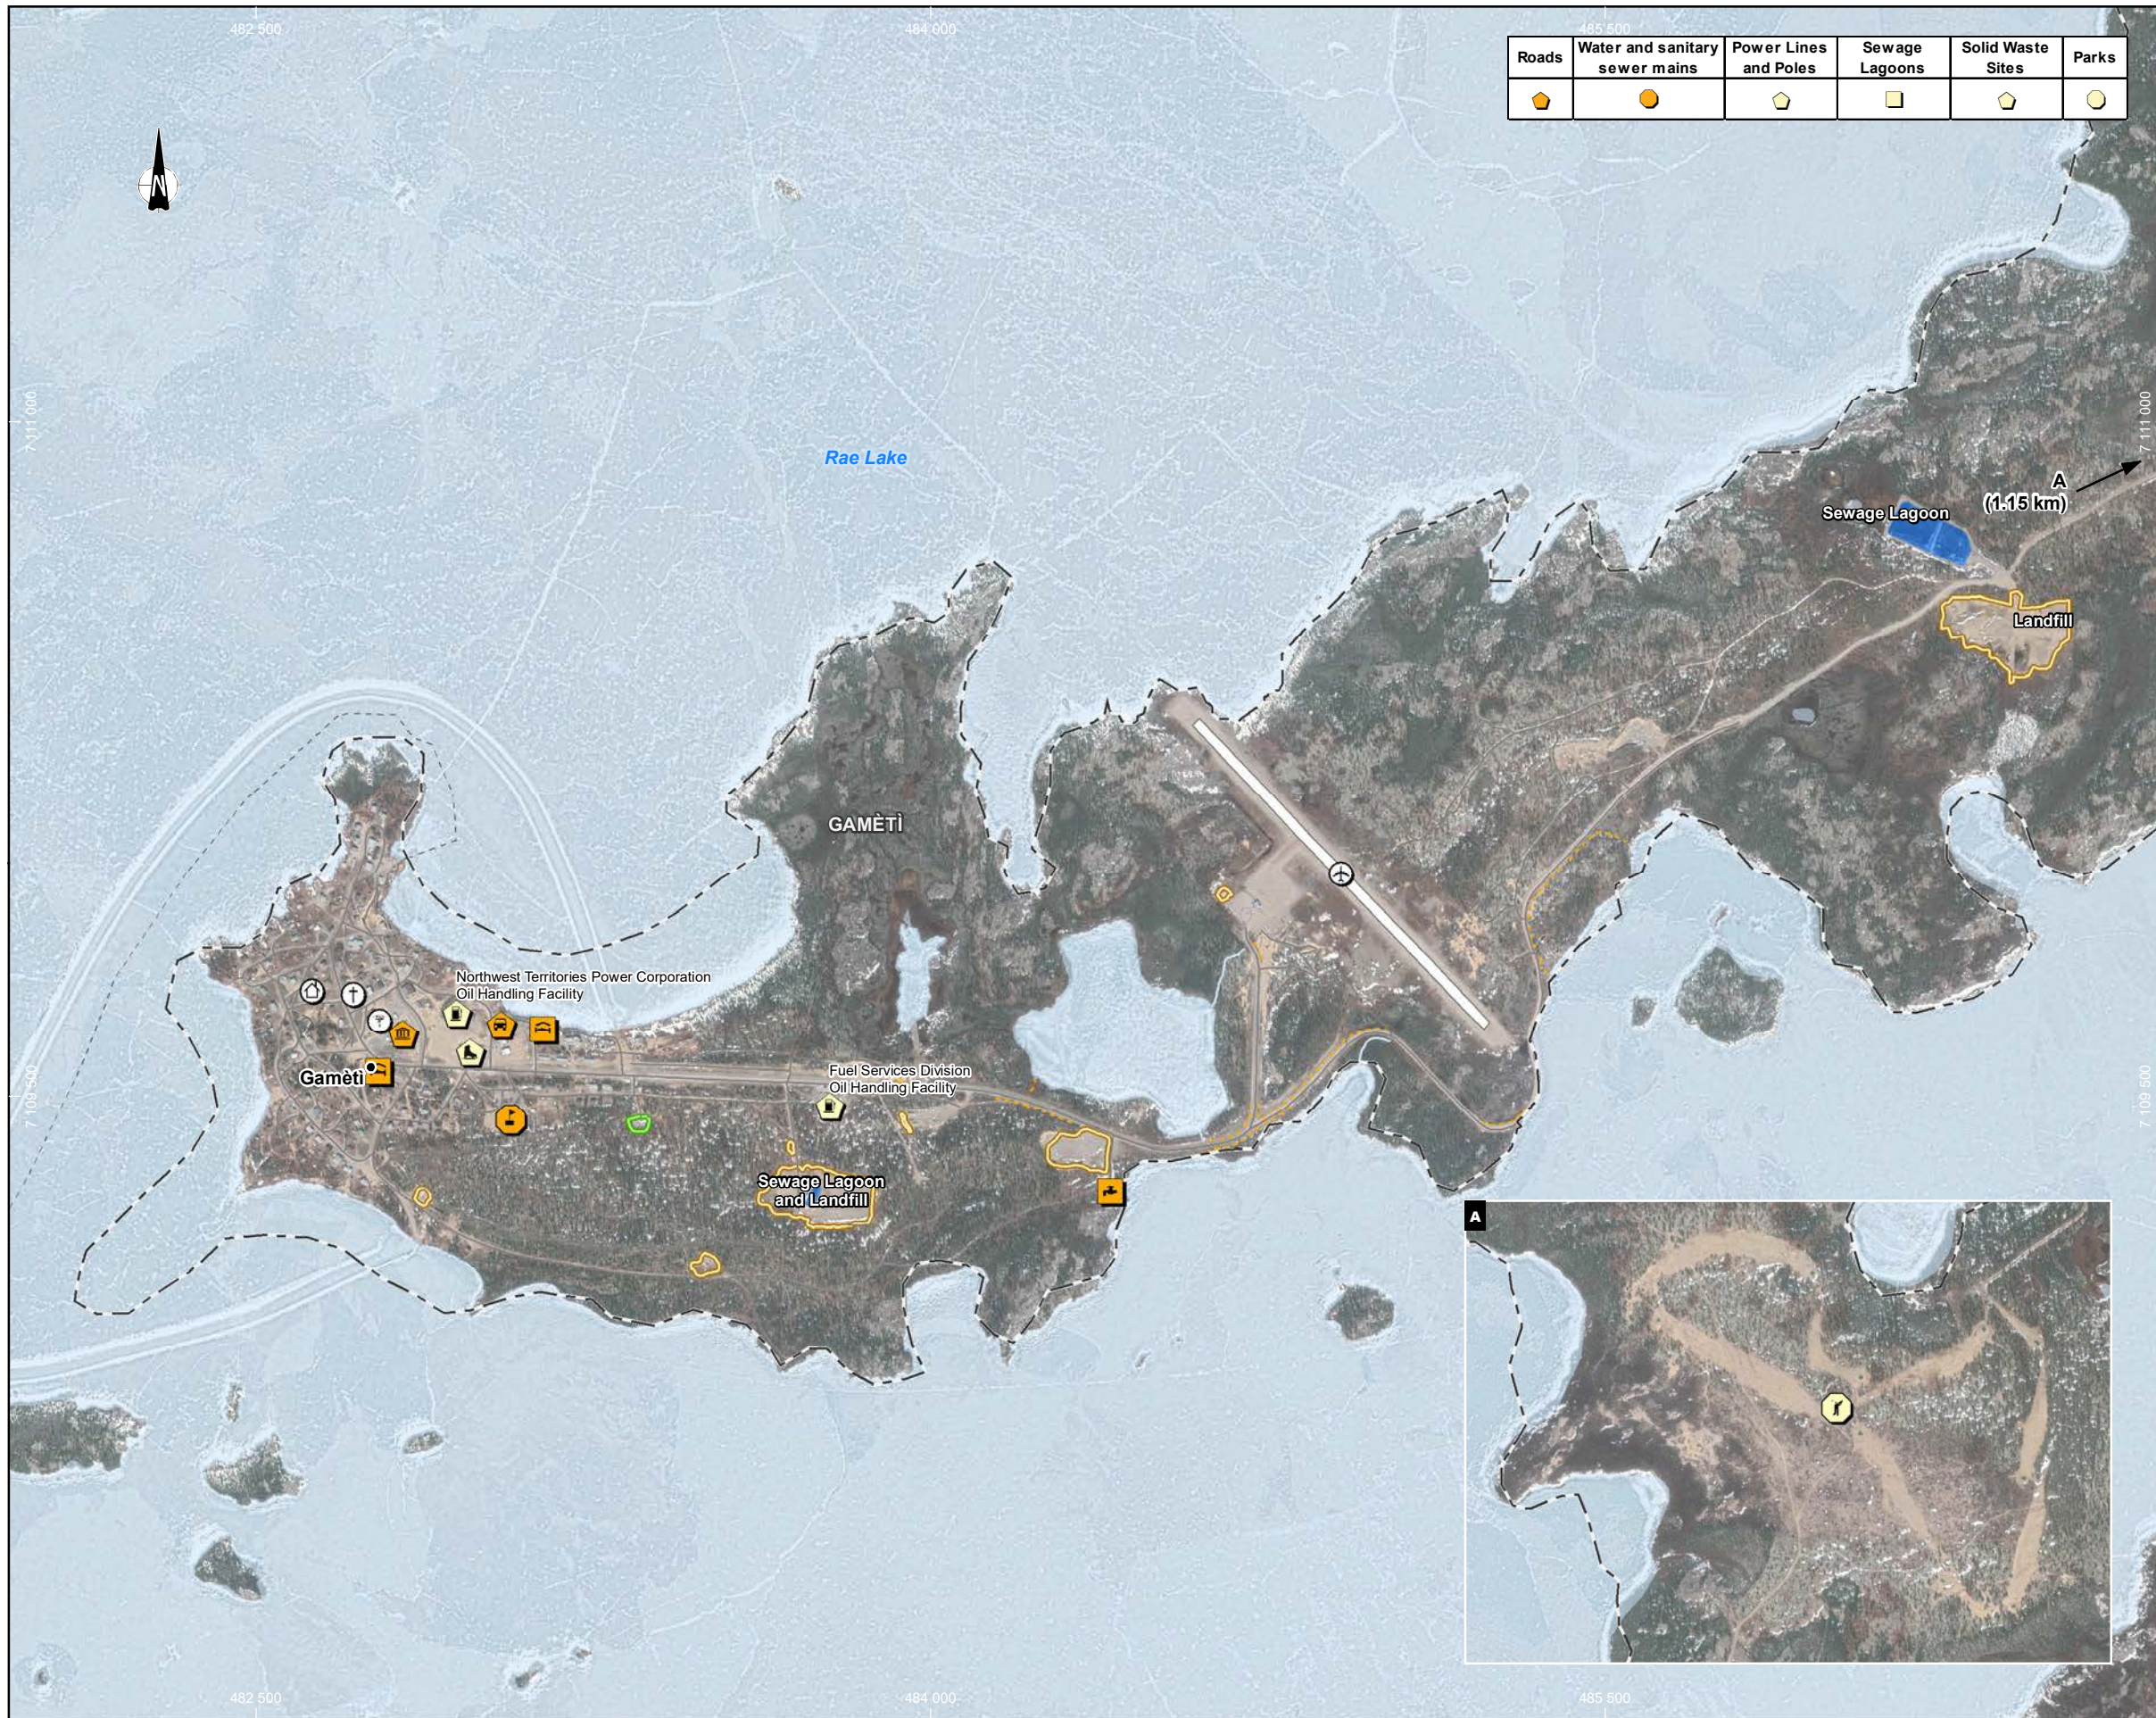
Municipal Boundary	Community
Leisure and Tourism	Golf Course
Park / Recreation Area	Lodging Facility
Arena	
<b>Ritual Cultural Area</b>	
Religious Building	
<b>Infrastructures</b>	Fuel Facility
Pits, Borrow Sites, Quarries, Dump Sites	Garage
Community Centre	Medical Centre
Educational Building	Municipal Hall
	Water Treatment Plant
<b>Transport</b>	Airport
Other street or road	
Trail	
<b>Hydrography</b>	Permanent Watercourse
Waterbody	Ditch
Lagoon / Reservoir / Dugout	
<b>Risk Type</b>	Precipitation Increase
No Identified Risk	Wildfire
Flooding and Coastal Erosion	Wind Increase
Permafrost Degradation	
<b>Risk Level</b>	Moderate-low
No Identified Risk	Moderate-high
Low	High
