Government of Northwest Territories
Assessment of Climate Change Impacts on Infrastructure in all NWT communities using the PIEVC protocol
 Northwest Territories, Canada

Map 13
Whati Risk Profile

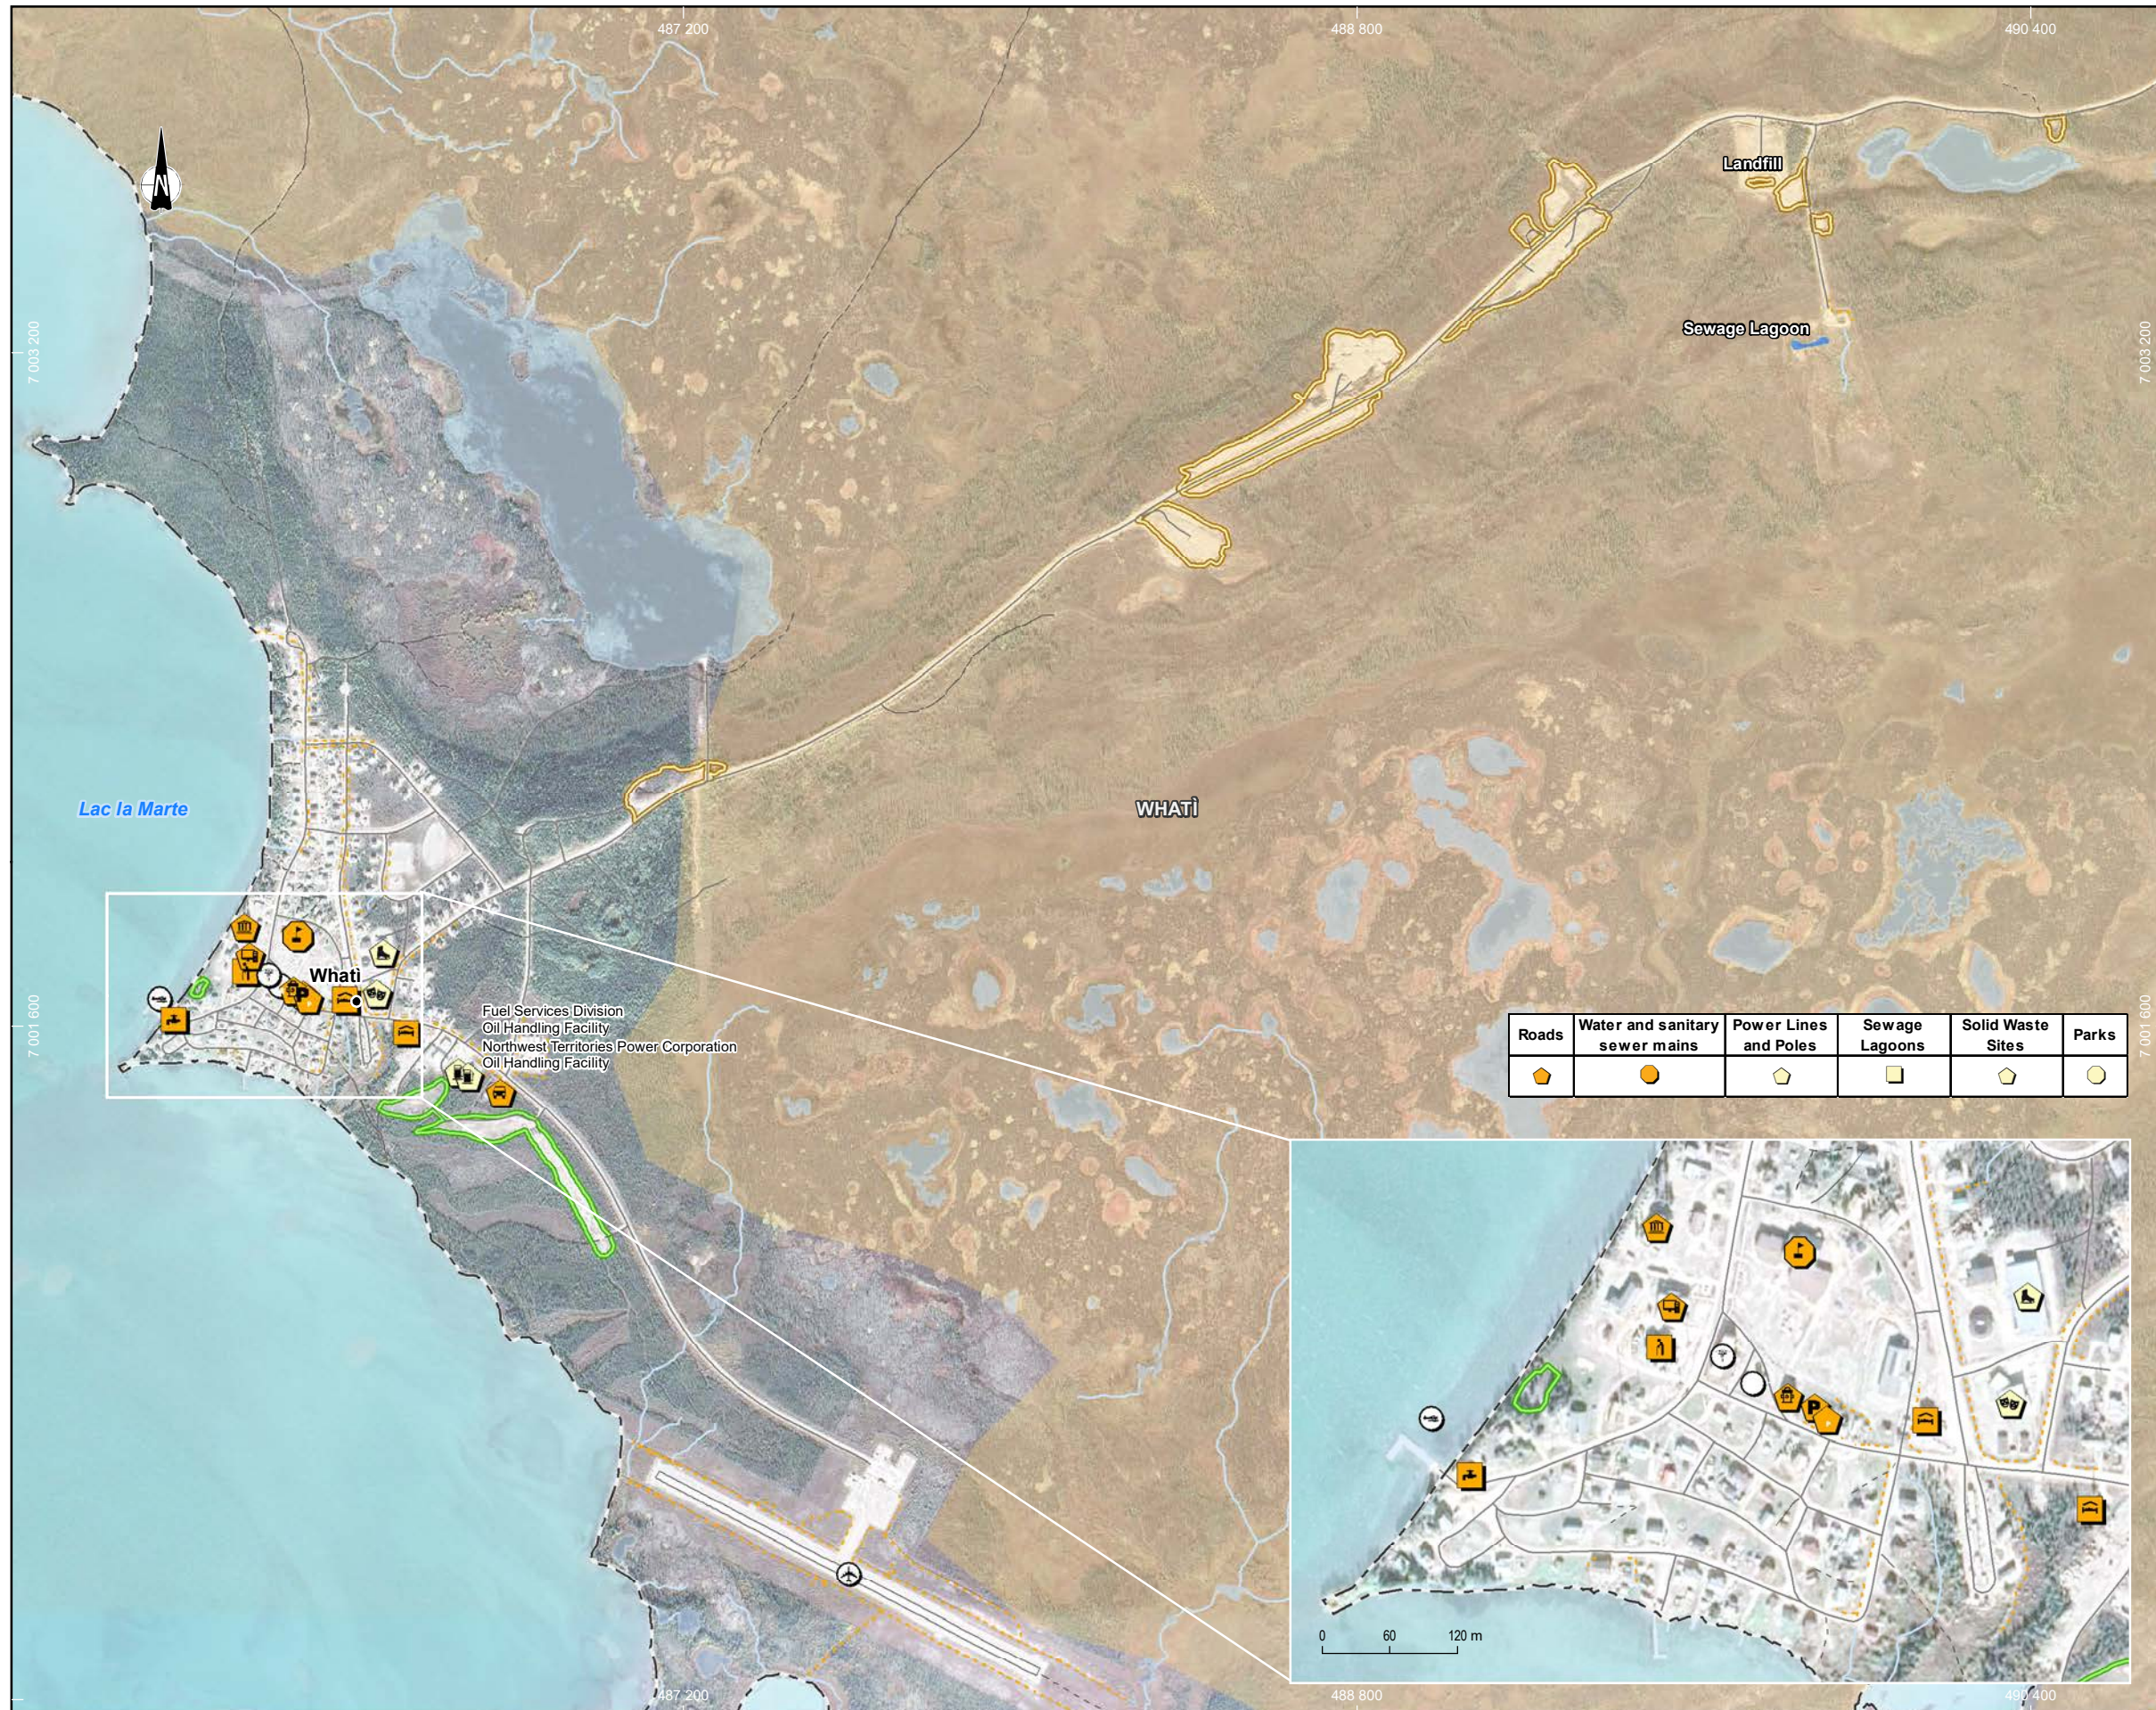
Municipal Boundary	Community
Historical Fire	Ritual Cultural Area
Leisure and Tourism	Cultural Centre
Park / Recreation Area	Medical Centre
Arena	Municipal Hall
Lodging Facility	Office
Infrastructures	Police Station
Pits, Borrow Sites, Quarries, Dump Sites	Power Plant
Biomass Plant	Senior Citizens Home
Educational Building	Water Treatment Plant
Fire Station	Airport
Fuel Facility	Seaplane Base
Garage	Permanent Watercourse
Transport	Ditch
Other street or road	Precipitation Increase
Trail	Wildfire
Hydrography	Wind Increase
Waterbody	Moderate-low
Lagoon / Reservoir / Dugout	Moderate-high
Risk Type	High
No Identified Risk	
Flooding and Coastal Erosion	
Permafrost Degradation	
Risk Level	
No Identified Risk	
Low
